SUMITOMO RECOMMENDED PROCEDURE

SRP SP-F04-011

FutureFLEX®

RESTORATION PROCEDURE DIELECTRIC TUBE CABLES & TUBE CABLE SPLICE KITS

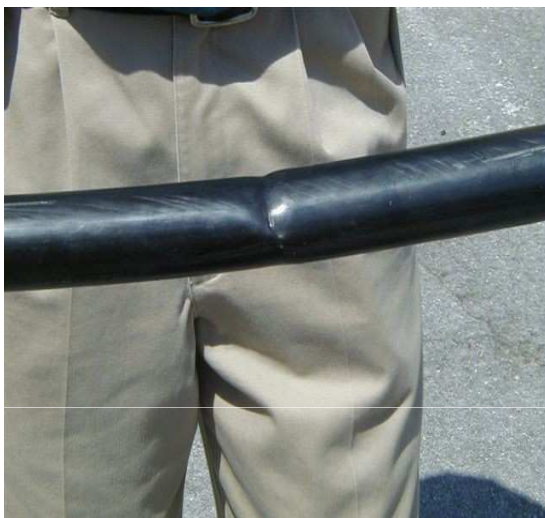
1.2 If a tube cable has been damaged, chances are that some or all of its inner tubes will no longer accept fiber bundle. **See Fig. 1.**

Figure 1
Badly Kinked Tube Cable

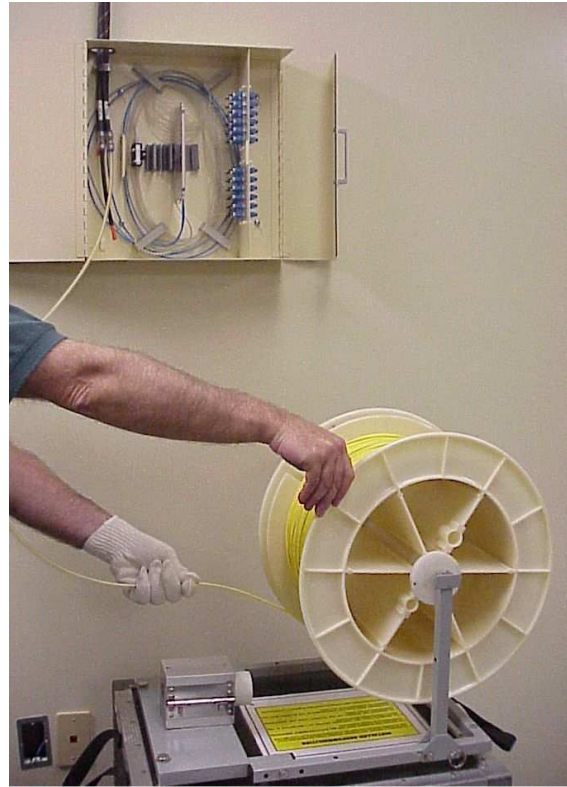
5.2.2 Blow fiber bundle out of tube and neatly guide onto reel. **See Fig. 2.**

Figure 2
Blow Fiber Bundle Out of Damaged Tube and onto Empty Reel

5.2.1 Set up a nitrogen bottle at entry point Fiber Termination Unit (FTU) and a Blowing Head with empty fiber bundle reel at exit point FTU.

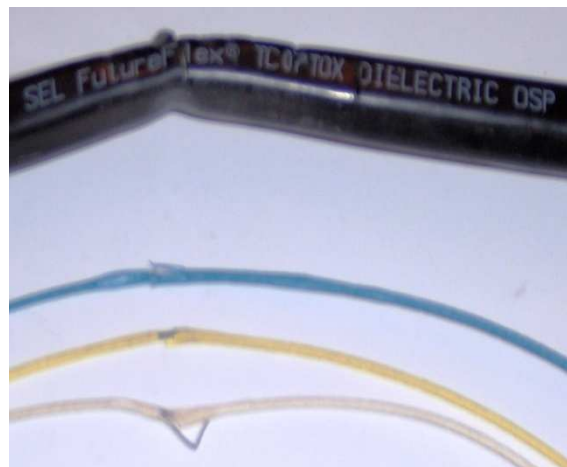
5.3 If the fiber bundle is damaged (some or all of the fiber optic strands inoperative), it should be scrapped and replaced. **See Fig. 3.**

Figure 3
Jacket Cut and Fiber Bundles Damaged

5.4 Set up a nitrogen bottle at entry point FTU and carefully blow fiber bundle out of tube directly into an appropriate trash container.

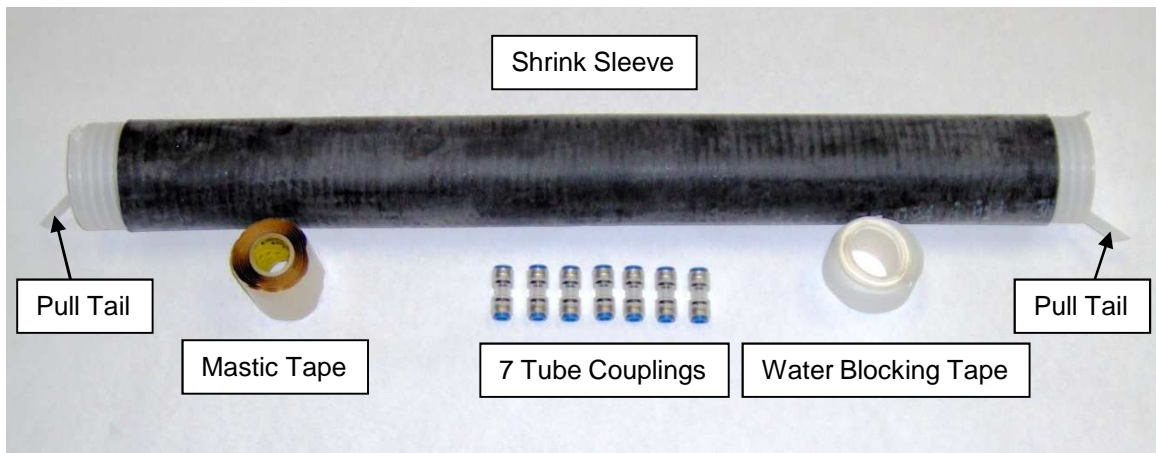
7.3 At both repair points, install Tube Cable Splice Kits in accordance with Sumitomo Recommended Procedure SRP SP-F04-016. **See Fig. 4.**

Figure 4
Tube Cable Splice Kit
(7-Tube Cable Kit Shown)

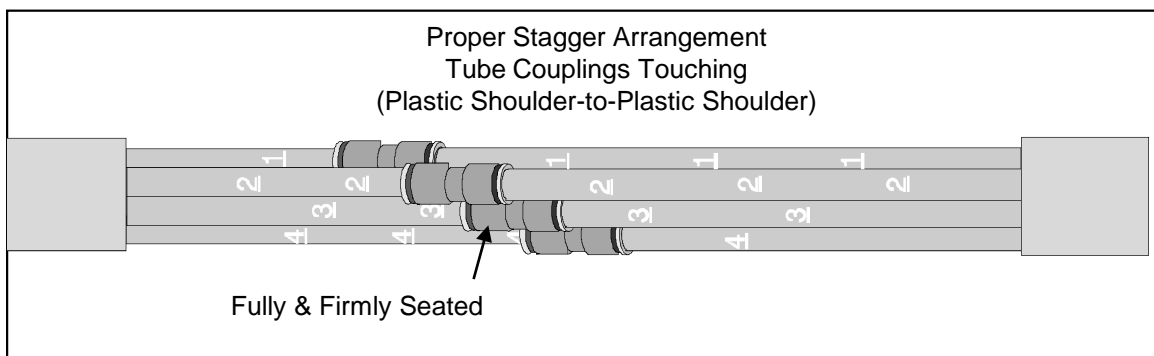
7.4 Be sure to accomplish Tube Coupling stagger arrangement at each splice point as described in SRP SP-F04-016. This arrangement places the plastic shoulder of one Tube Coupling against the plastic shoulder of an adjacent Tube Coupling. This is necessary to prevent a Tube Coupling from being pressed into and possibly compressing / kinking an adjacent bare tube when the shrink sleeve is collapsed. **See Fig. 5.**

Figure 5
Tubes Coupled in Proper Stagger Arrangement

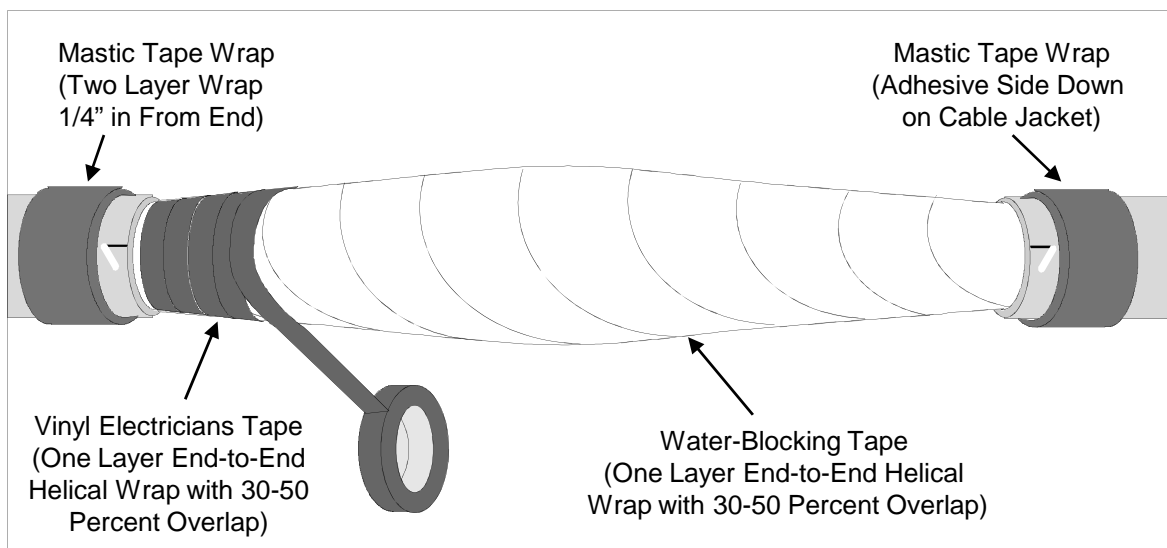
7.6 After the tubes are tested, waterproof each splice point by wrapping the exposed tubes with water blocking tape and applying mastic tape wraps on the tube cable jacket ends. **See Fig. 6.**

Figure 6
Waterproofing the Splice

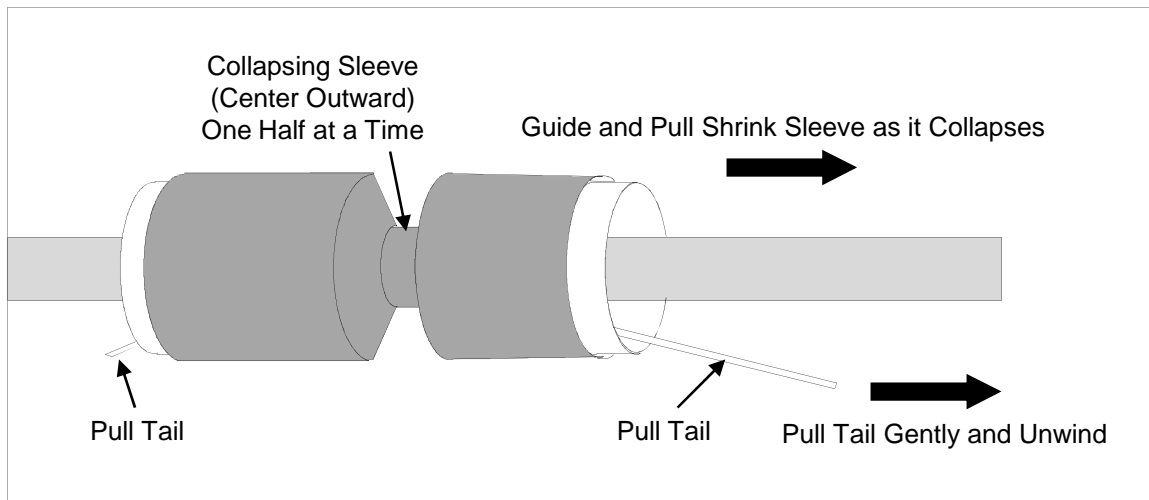
7.7 Collapse the shrink sleeves over the coupled tubes by carefully pulling on the sleeve's Pull Tails. **See Fig. 7.**

Figure 7
Collapsing Shrink Sleeve for 7- and 19-Tube Cables

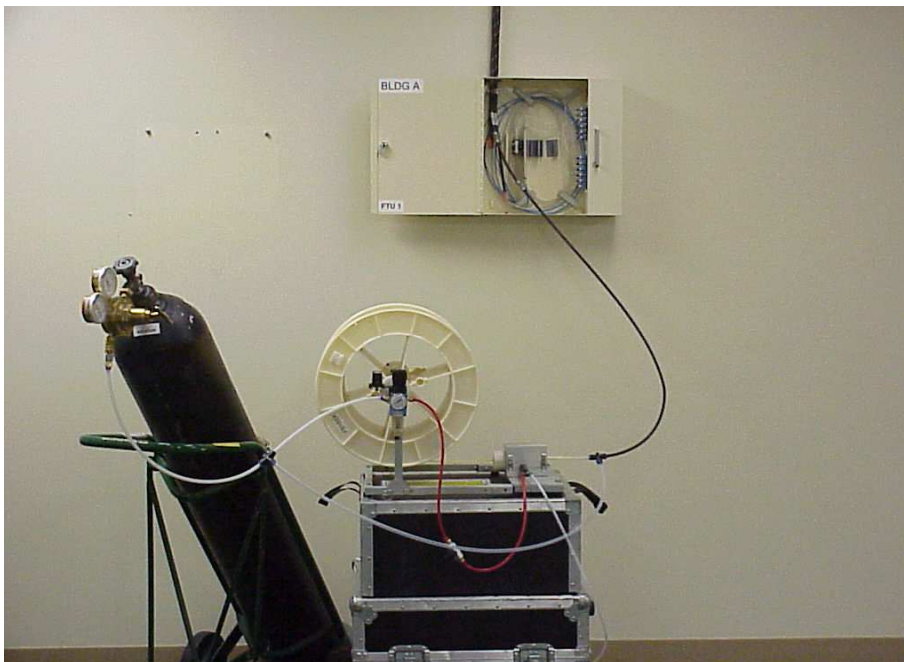
8.2 Refer to Sumitomo Recommended Procedures SRP SP-F04-001 and SRP SP-F04-002 to set up the Blowing Head Equipment and install replacement fiber bundle. **See Fig. 8.**

Figure 8
Blowing Head Set Up and Ready to Install Replacement Fiber Bundle
